Published date	12/07/2021
Document number	SUPAIR_2021_06_001
Page number	1/2

SAFETY CHECK REQUEST

SUBJECT : WALIBI LITE harnesses manufactured before 2019

Request to check the extraction of the rescue parachute on WALIBI LITE harnesses manufactured before 2019

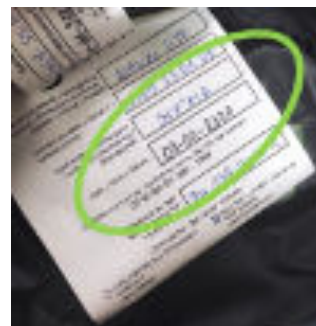
You can find the date of manufacture on the label in the back pocket of the harness.

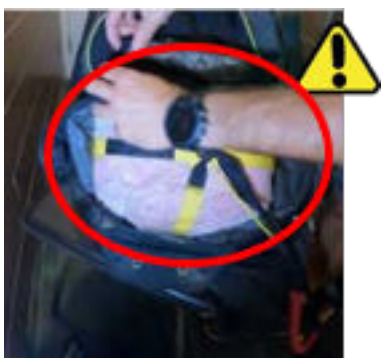
CHECK under a gantry that the rescue parachute can be extracted and that the inside of the parachute pocket does not stick to the rescue parachute.

The rescue parachute can't be extracted or the inside of the parachute pocket sticks and interferes with the correct extraction of the reserve parachute

Contact SUPAIR : sav@supair.com
