**Safety report for paragliders PHI with R07 risers (01/11/2024)**

**The carrying straps R07 for the  
samples - ALLEGRO X-alps (later ALLEGRO light)  
- MAESTRO 2  
light -**

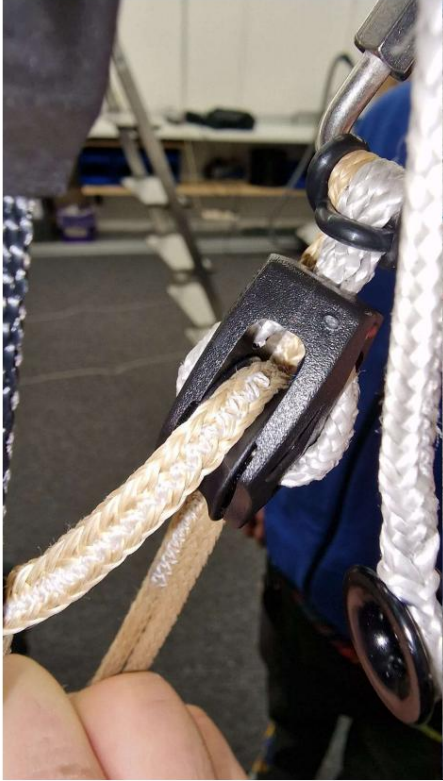
illustration 1

**Technora leash from Edelrid. Presumably the friction on a sharp edge of the pulley (Ronstan) caused damage to the line and weakening it to the point of breaking. When it comes to ranking, there is a series variation among the roles used.**

**Roll with sharp edge: Figure 1**

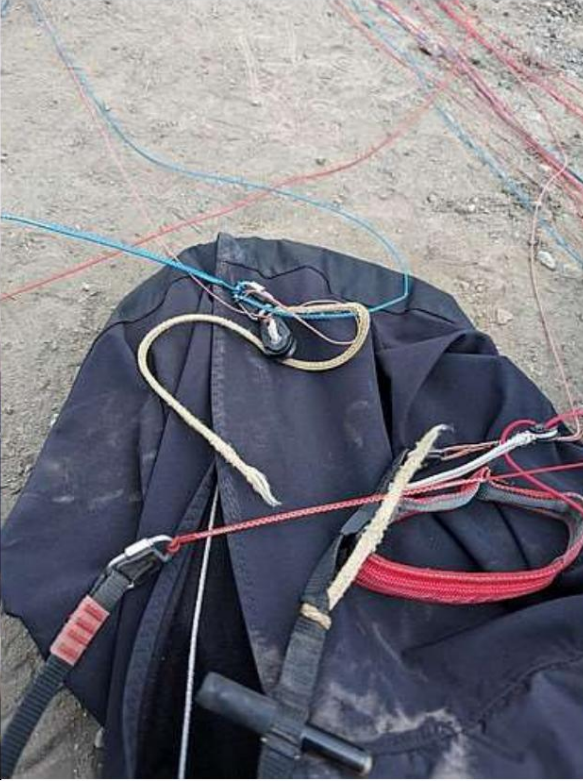
Figure 2

**Broken, heavily worn (rubbed) line: Figure 2**

**From the visual impression of the risers, the paraglider in question was very heavily used. There are clear signs of abrasion on the leash.**

**MAESTRO 2, as well as all other PHI samples that are equipped with the optionally available R07 risers (Figure 3), must be subjected to a visual inspection. The check can be carried out by the owner himself and must be carried out before the next flight. If damage or wear is discovered, the owners are requested to stop flying the affected paraglider and to contact PHI or their PHI dealer about replacing the affected line and, if necessary, the pulley.**
