Investigation into incidents involving the Paralock 3 paragliding carabiner

DHV Safety and Technology

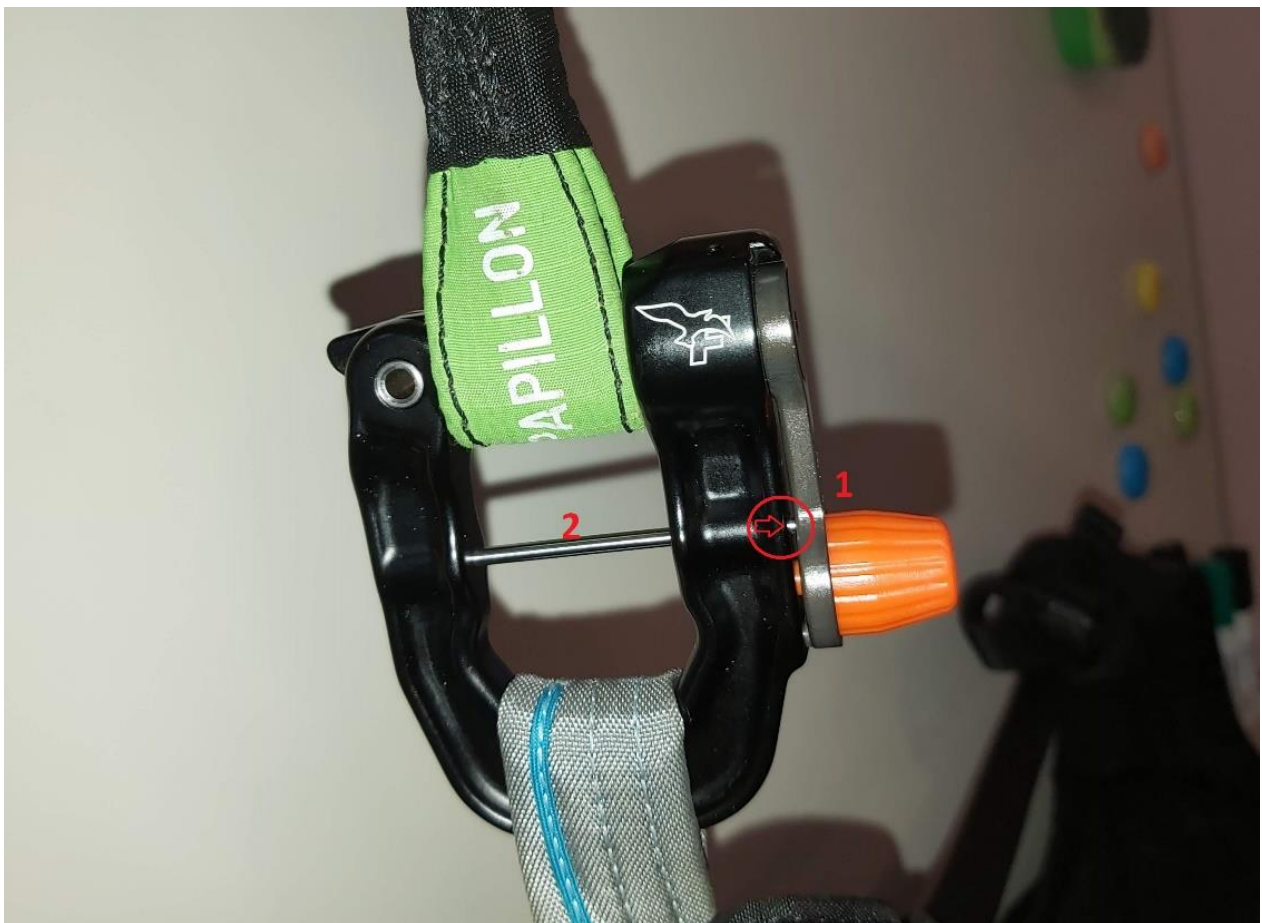
1. Correct assembly

If the release lever (1) is engaged in the lower position with an audible click and the securing pin (2) has been locked (circle), it cannot be opened unintentionally. The release lever cannot be operated with the release knob (orange) in this configuration.

This configuration is specified in the operating manual for all operating modes.

Caution! In previous manuals, operation without a locked securing pin was permitted for single-seat gliders but not for tandems.

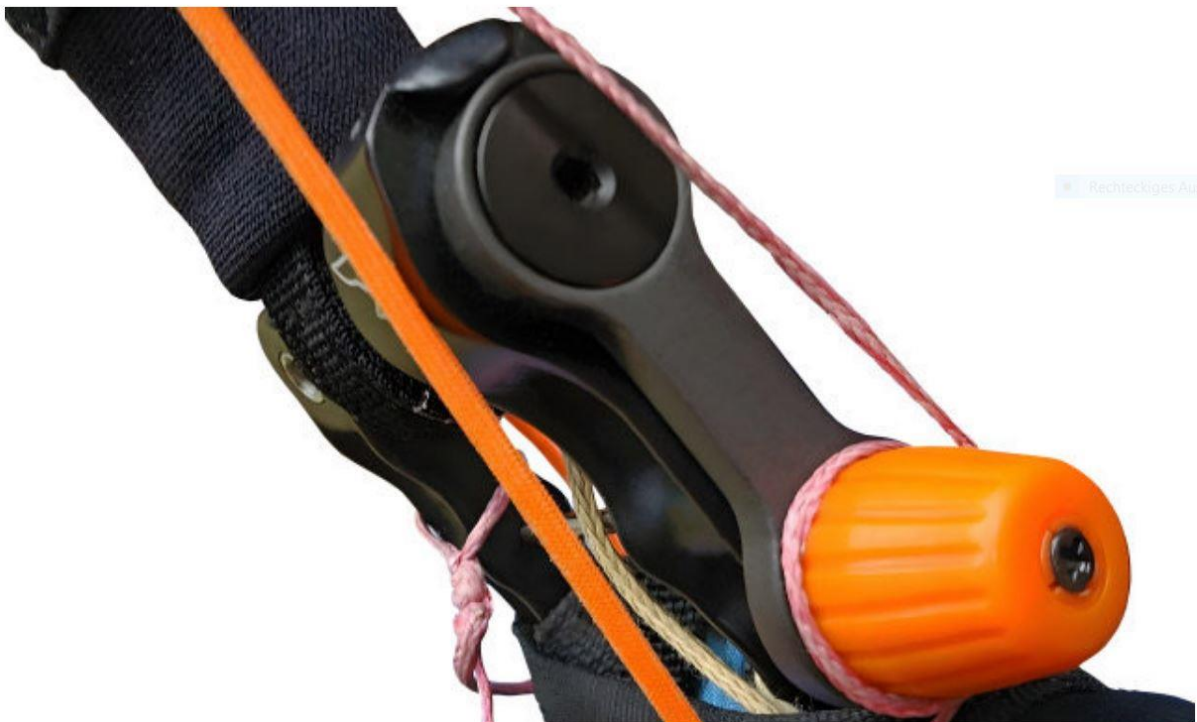
Illustration from the Finsterwalder safety note from 7 July 2024

A loose speed bar line was the cause of at least two of the reported incidents. The loose speed bar line wrapped around the release button of the release lever and, during subsequent acceleration, led to the activation of the release mechanism and opened the carabiner. The first incident was reported to the DHV on 21 June 2024 and led to a [safety note from Finsterwalder on 7 July 2024](#). The safety note stipulates that pilots may only use the Paralock with a locked securing pin. This applies to all operating modes of the carabiner. The second incident occurred on 20 July 2024.

1. The pilot must often move the release lever manually into the locked position, as it does not always snap in and lock automatically.
2. If lines are looping around the release knob and these lines are then getting tension/load, the release knob can open. With an unlocked securing pin, this can lead to an opening of the carabiner.
3. There is no option for the pilot to visually make sure if the securing pin is open or locked. The securing pin has no visual control to inform the pilot of the open or locked state.
4. Due to the slim design of the securing pin, its operation requires increased attention, especially when wearing gloves.
5. Pilots can close the securing pin even if the release lever is not snapped shut and locked into place. This leads to the release lever being completely unsecured and able to easily open unintentionally.

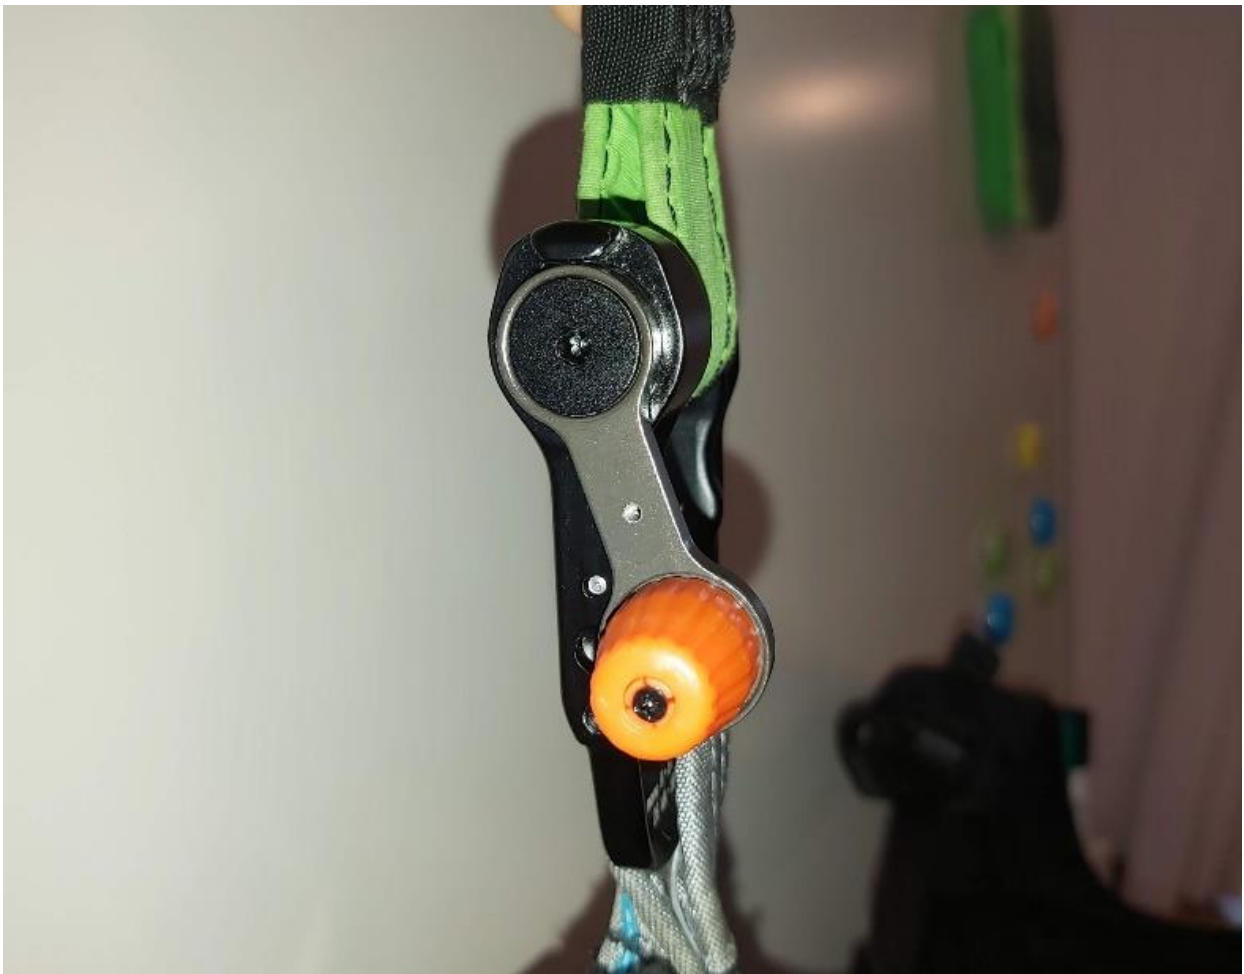
The spring of the release lever is not strong enough to ensure that it always snaps shut and locks into place automatically. [This video shows a demonstration](#). If the pilot lets the release lever go after attaching the riser, the spring force is sufficient to allow the lever to snap shut and lock into place in the lower position. However, if the pilot leads the release lever down slowly, it will not snap shut and lock into place by itself. In this case the pilot must move the release lever manually into the locked position.

Release lever not snapped shut and locked into place.

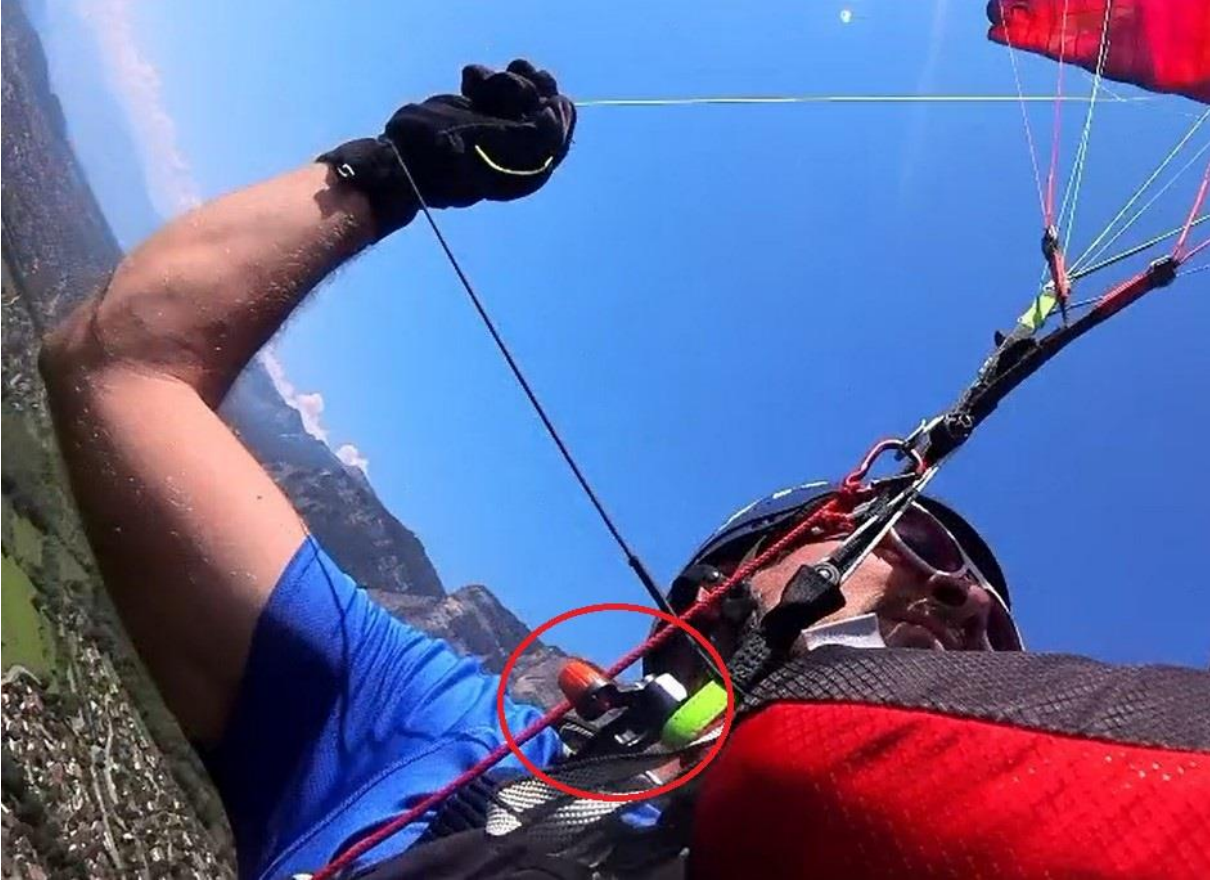
In this video freeze frame, you can see that the line of the speed bar is pushing the non-locked release lever. As the flight progresses, the speed bar line opened the Paralock 3. The pilot landed with the reserve parachute.

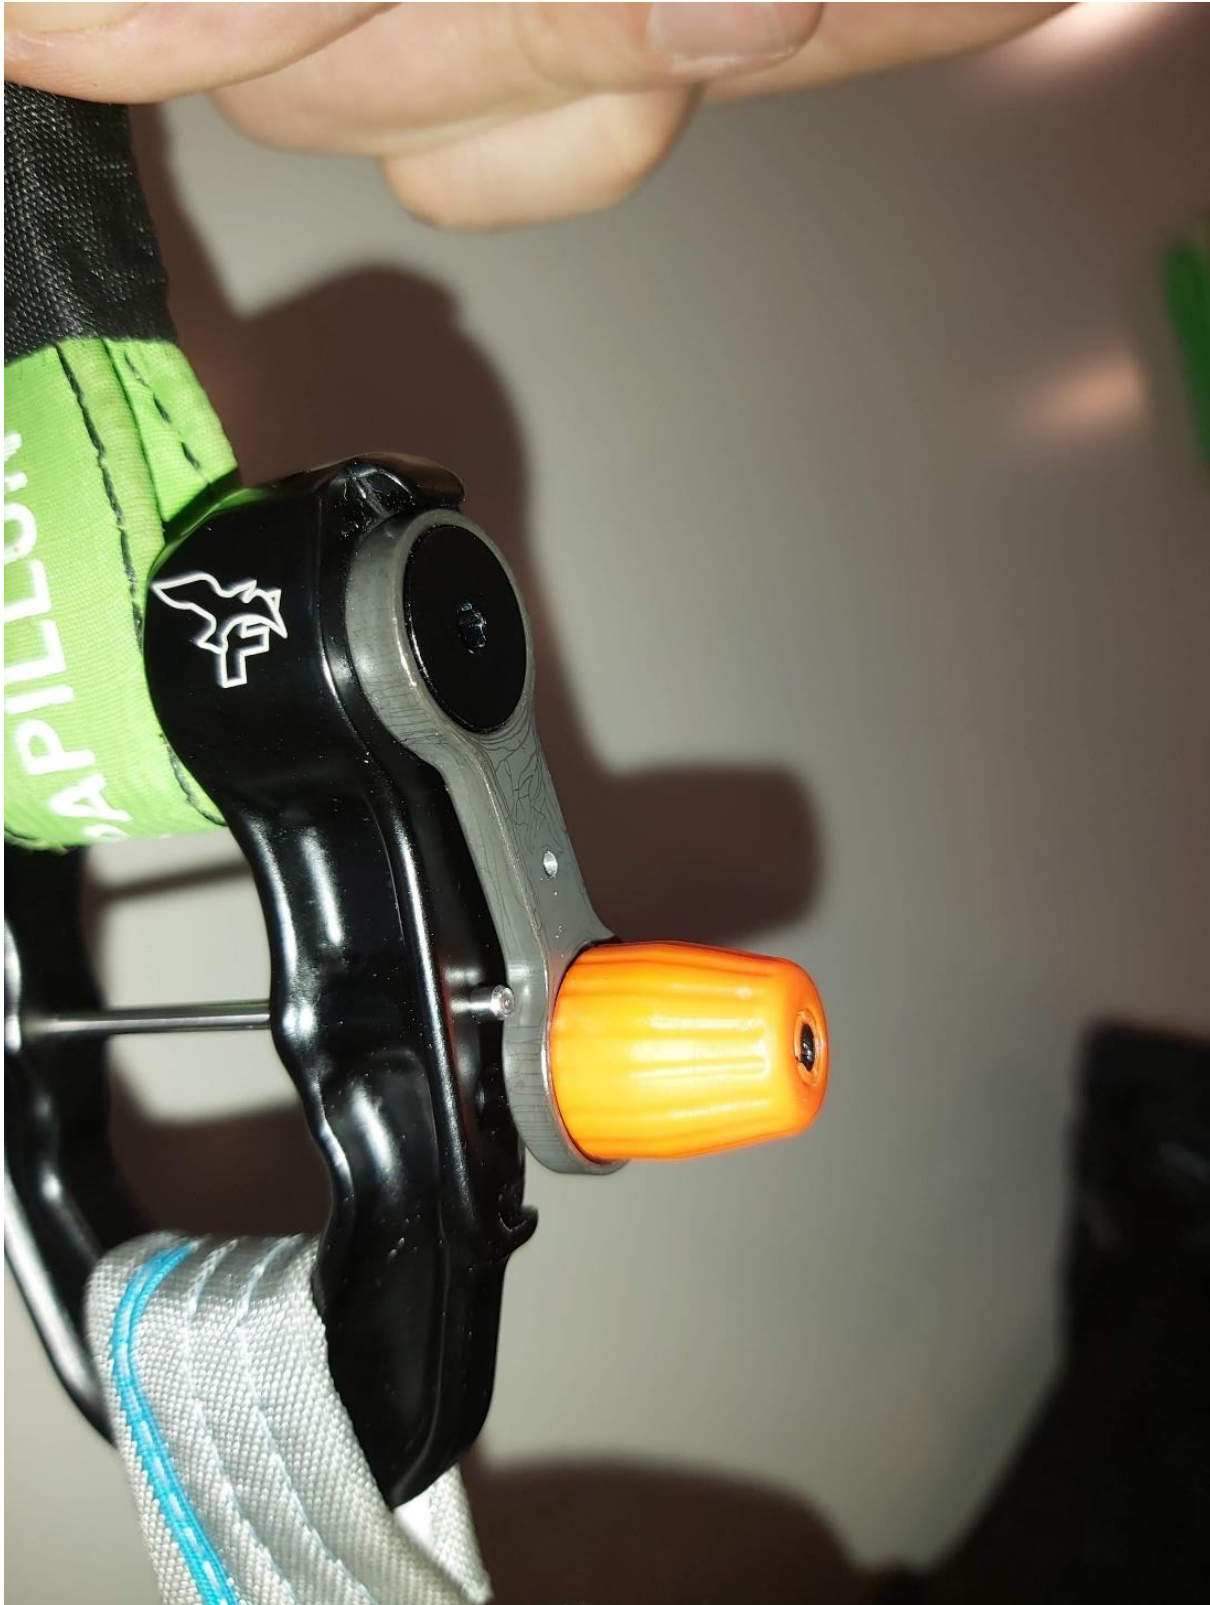
Pilots can push the securing pin into the locked position, even if the release lever is not snapped in. However, it then does not connect to the release lever and therefore does not secure it. Instead, the securing pin blocks the release lever in an unlocked position, where it is no longer able to snap shut and lock into place. The release lever remains completely unsecured. A little force, for example a steering movement, the line of the speed bar or low loaded (loose) lines after a collapse can move the release lever upwards unintentionally with little force and thus release the riser.

The quick-release function of the Paralock 3 requires a complex mechanism. Users of the Paralock 3 must familiarise themselves thoroughly with its functions and possible operating errors. They must conduct the necessary checks consistently and thoroughly before each flight. Pilots may only use the Paralock 3 if the release lever is snapped shut and locked into place and the safety pin is locked. This must be checked thoroughly by making sure that the release lever cannot be opened with the release knob. Always follow the operating manual!
